**Objective:** To observe the effect of joint expansion in respect of a joint sealant section 4.5mm wide by 3.5mm deep.

## Test Report

Test Report July/2114

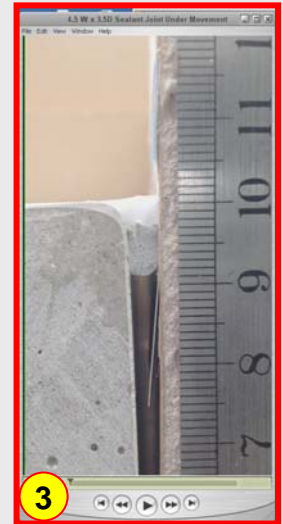
**Test: (photo 2 & film clip 3):** The shower tray was moved downward to simulate joint expansion in the intended shower environment.

**Observations:** Horizontal joint expansion generated shear tensile force in the sealant. This shear tensile force was absorbed through both elongation of the sealant and deflection in the HydroHALT strip particularly along its point on connection with the sealant.
